Service Bulletin

Product Name: FLO-GARD 6201 Volumetric Infusion Pump

Title: Application of Adhesive Tape to Front Panel Keypad Flexi Connector

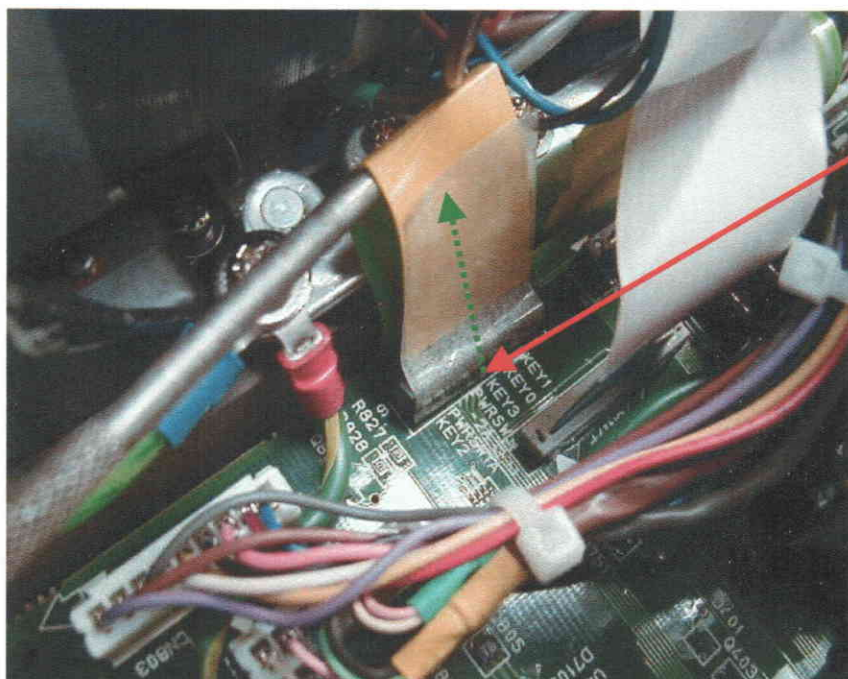
Some pump failures such as; the device will not power on or the buttons on the keypad do not function are caused by the ribbon cable of the Front Panel becoming dislodged from Connector CN601. Application of adhesive tape to secure the keypad ribbon to connector CN601 will reduce failures associated with the dislodging of the flexi connector.

- 5.1 Separate the front and rear case assemblies following the instructions in the FLO-GARD 6201 Volumetric Infusion Pump Service Manual.
- 5.2 Ensure flex cable is fully seated in the CN601 connector.
- 5.3 Cut a 1 ¼ " length of 3M44 Electrical Tape.
- 5.4 Attach the tape to the front side of the CN601 connector starting at the base and flush with the sensor board. Continue attachment moving up the connector to the flex cable ensuring tape is bonded firmly. Refer to Illustration below

Apply tape from bottom of CN601 and move upward for proper application of adhesive tape
